UPPER LITTLE BLACKFOOT RIVER RESTORATION PROJECT

An Upper Clark Fork River Basin Restoration Grant Proposal

March 2, 2006

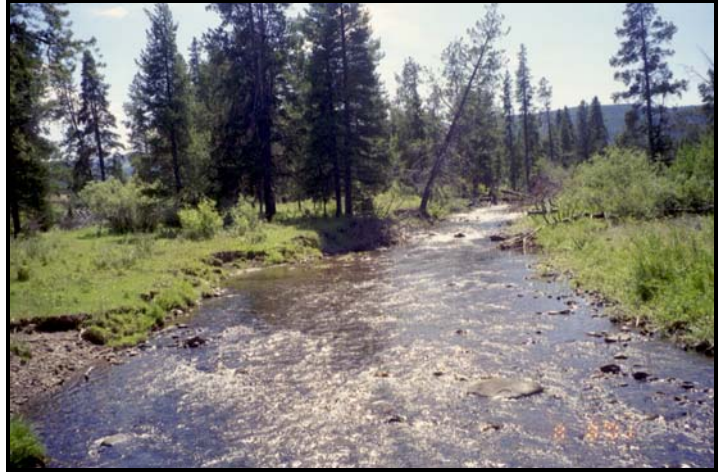
Photo 2: Increasing width/depth ratio and declining vegetative condition.

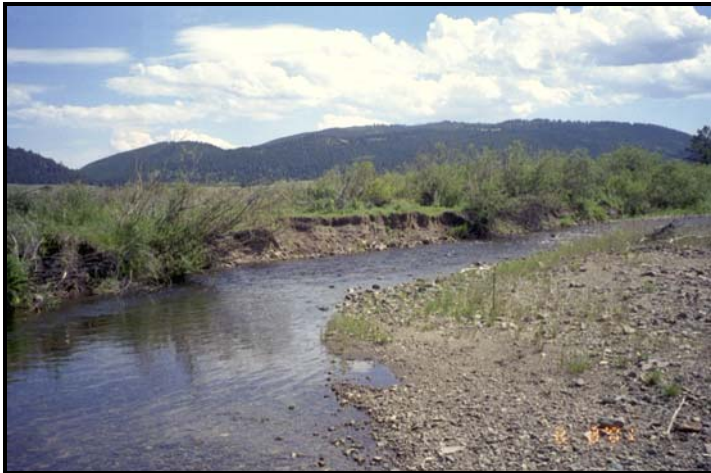
Photo 3: Raw banks and sediment deposits.

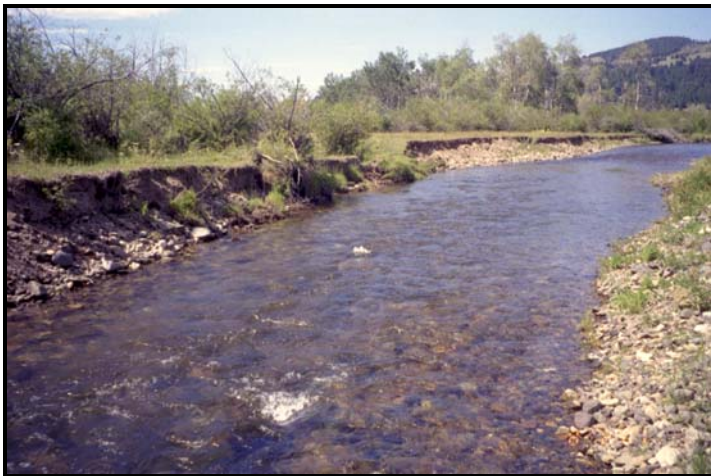
Photo 5: Unstable banks near Mike Renig Gulch.

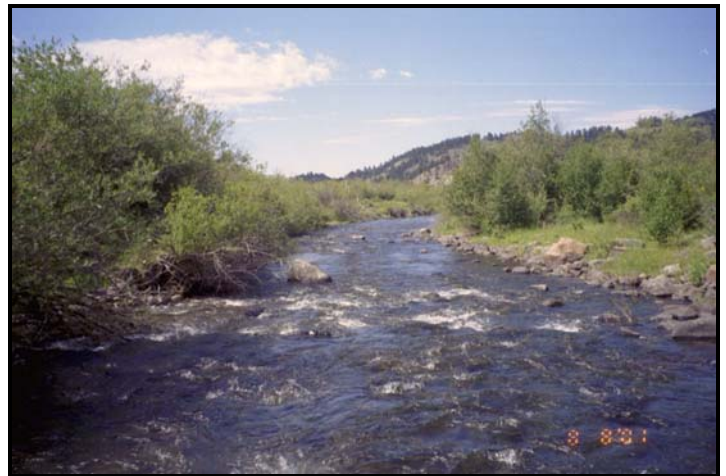
Photo 6: Reach 6B – Stable section with rock and woody vegetation upstream Highway 12.
